Desktop 3rd Generation Intel[®] Core[™] Processor Family

Specification Update

April 2015

Revision 021

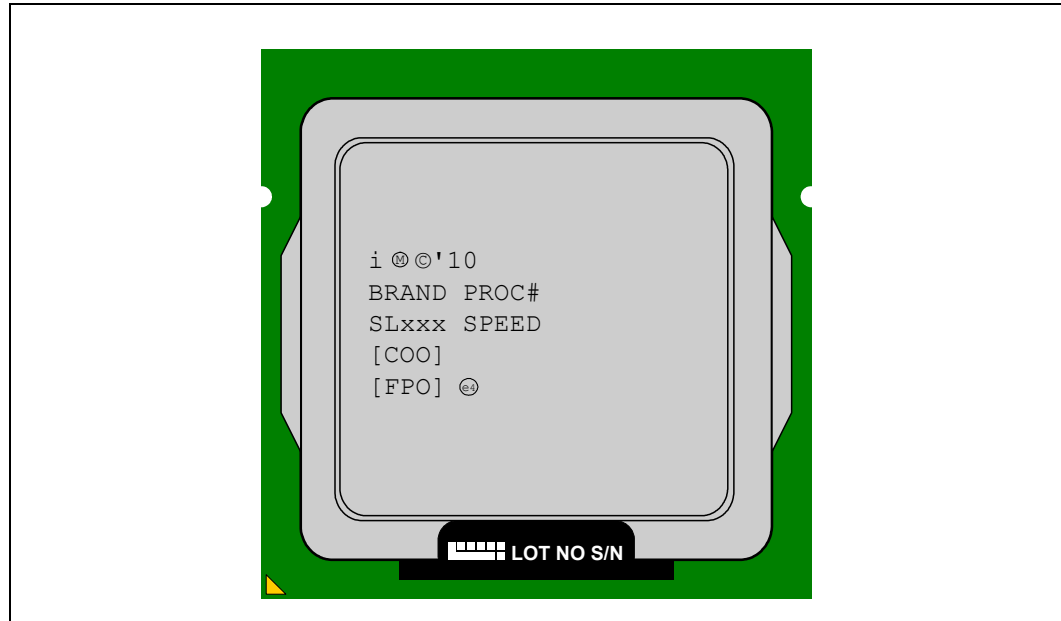
Figure 1. Processor Production Top-side Markings (Example)

The processor stepping can be identified by the following component markings.
